BITURBOX

A “plug and play” replacement for the fuse box of the Maserati BITURBO family
Compatible with all Biturbo type cars made from 1981 to 1994 (Biturbo to Shamal, no ABS)
Replaces Maserati part No. 313020104 (inside board only) and 313020339 (fuse cover)

User manual

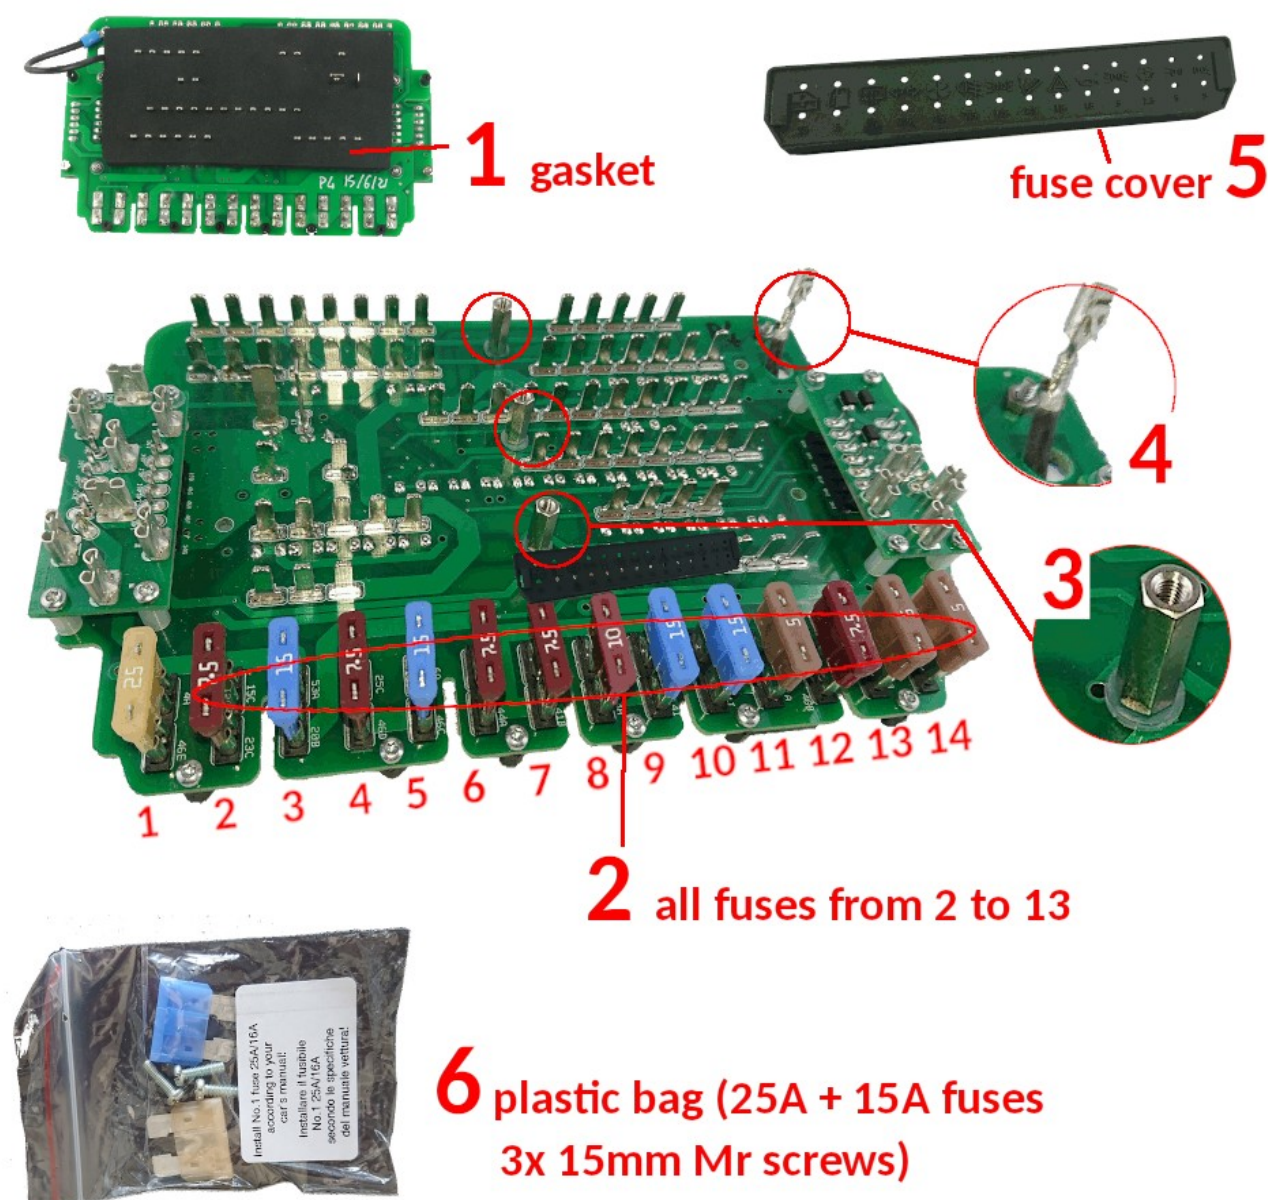
Also, please check the picture and verify that all of the following is assembled on your Biturbox:

- 1) rear black rectangular gasket, assembled on the board
- 2) all the fuses except fuse No.1, which is found in the plastic bag at point 5 below
- 3) 3 hexagonal spacers, 15mm long, on the front of the board.
- 4) ground cable
- 5) fuse cover

Also, on the bottom of the box, under the Biturbox circuit:

- 6) plastic bag with 25A, 16A fuse, 3 pieces of M10 screws

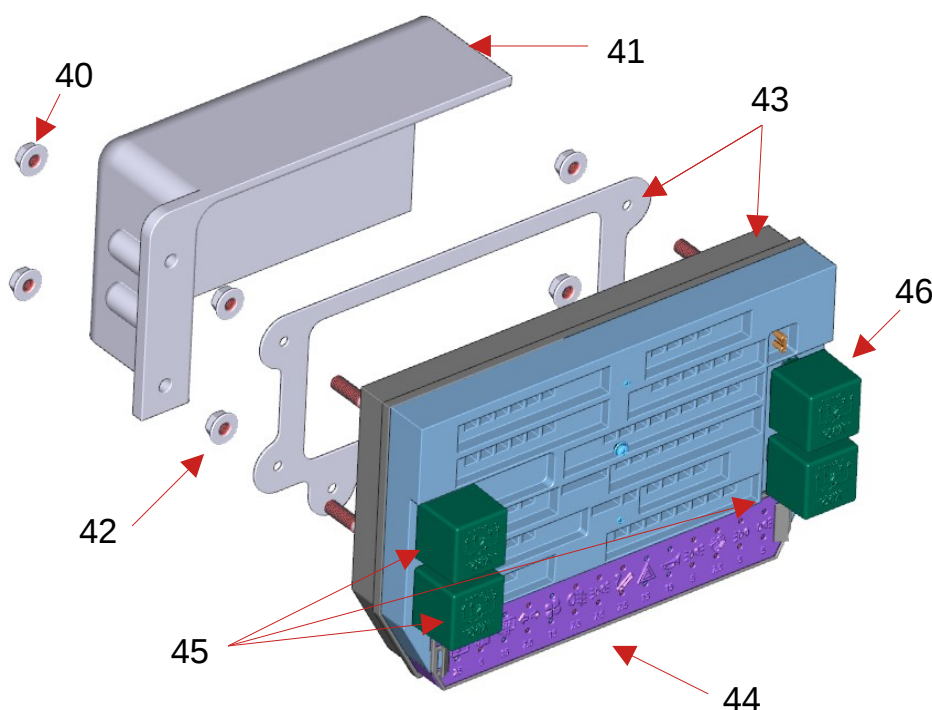
Anyway, the fuse box (43) is located between the engine bay and the passenger's side of the cockpit, and is held in place by its own four M6 screws (42), tightened by corresponding nuts on the engine bay's side. On top of that, a fuse box guard (41) is also kept in place by two further M6 nuts (40).

Remove the diode box (46) and the three relays (45). Keep relays aside (45). **Do not mix them with the diode box (46)**, which will not be used anymore as the diodes are now an integral part of the new circuit board.

Use a T-handle cardan M6 (10mm) wrench to remove the two (40) nuts, used to keep the fuse box guard (41) in place, and then remove the said guard.

To unscrew the two nuts (42) which are on the opposite side to the nuts (40), i.e. those close to the vehicle's mudguard, it is likely that it will be necessary to remove the relay supports which are between the right dome and the bulkhead between the engine and interior: use a thin flat-tip screwdriver to release the plastic supports on which the relays are mounted from their fixing flange: insert it from the top, in the central part of each relay holder, and carefully separate the support from the flange. Repeat for all supports, and gently move them aside, making sure not to damage the underlying wiring.

Now unscrew the remaining four M6 nuts (42), and finally take your fuse box (43) out of the car.

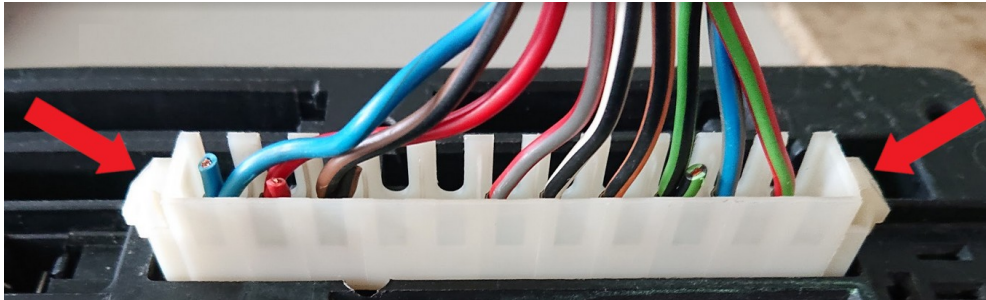
With care, remove all the connectors that go into the fuse box from either side of the car: to do so, most connectors (but two) must be pressed from both sides to release the locking clips. This is why the relay and diode boxes must be removed before removing the connectors.

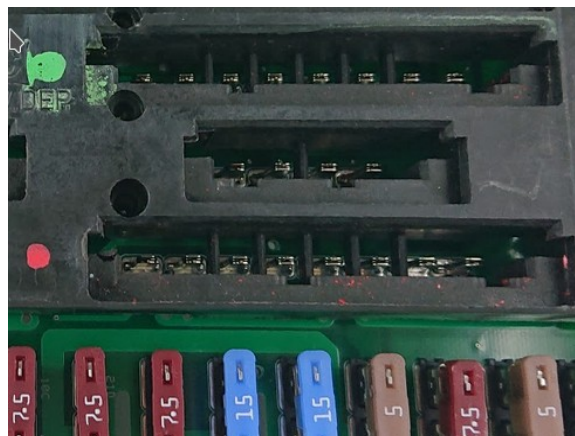
There is no risk of mismatch as all the connectors can only go into their matching female. An exception to this may be a green and red connector, in some older cars. If so, the red connector is the one near the fuses, as shown by the dots in the picture below:

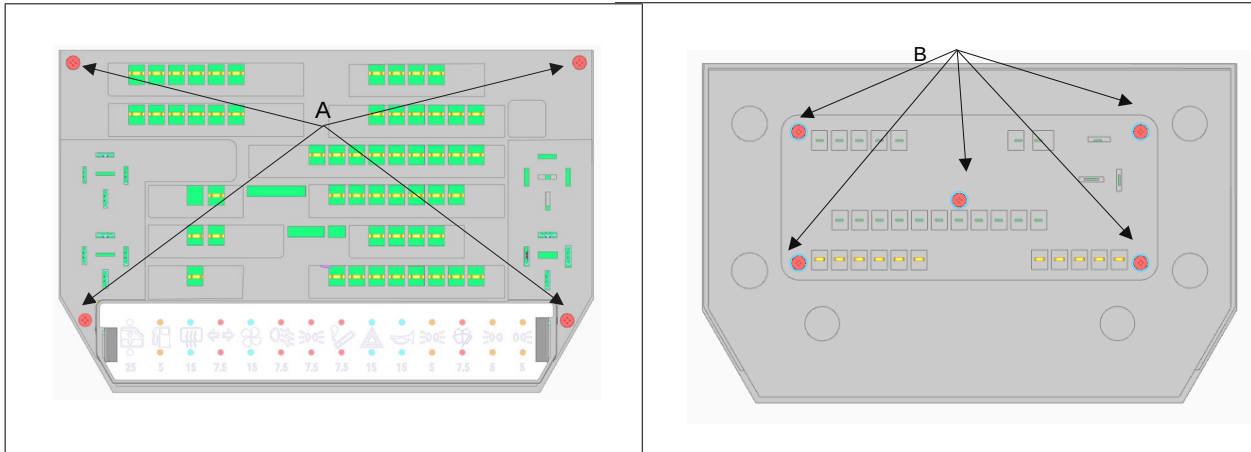
Unscrew the four screws (A) then remove these screws (B). Keep them all aside

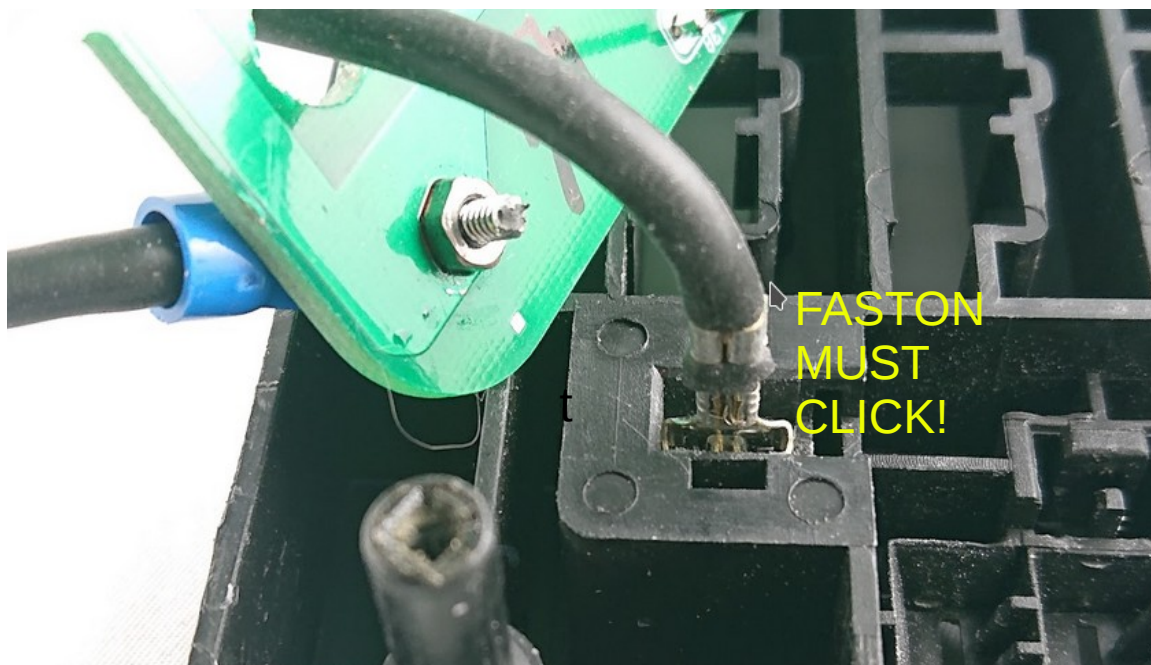
Make sure that the ground wire's faston is inserted in the matching hole in the old case. The faston has a little retaining tab that MUST "click" when inserted in place.

After you've inserted the ground wire, pull it gently back: if it's properly inserted, it won't come back.

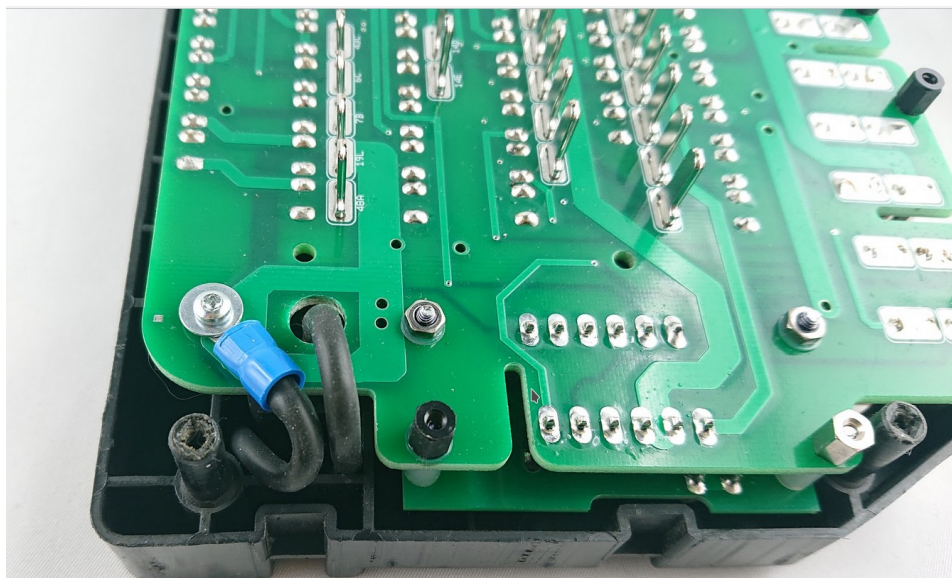
Verify that the ground wire is folded like this:

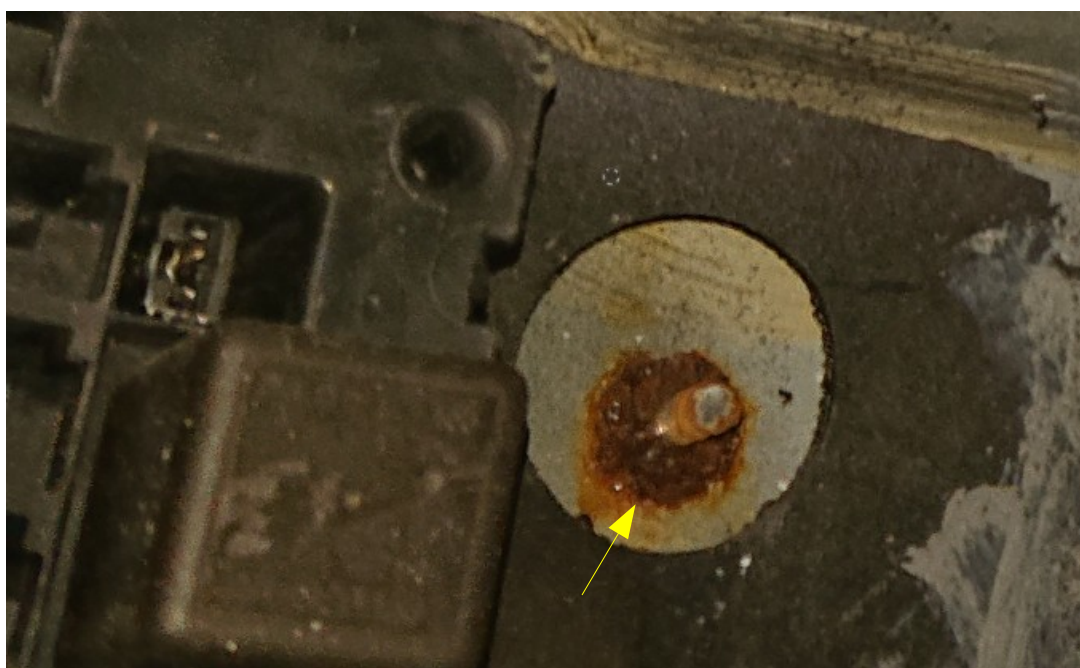
The fuse box is grounded externally through a black cable which runs all the way to a ground connection on the right side of the box itself. Take the time to verify that the ground connection on your car is good: if necessary, remove the M6 nut, clean the connection from any rust (iron oxide is non conductive!), and reassemble it. The following picture details how the ground connection near the fuse box should NOT look like! Note, in the left hand side of the picture, the ground connector of the fuse box right above the diode box

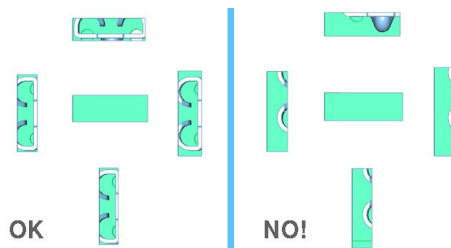
1 - check alignment of the female with regards to the slots in the shells. The male pins must enter properly and fully in each female. This must be true for each pin of each relay.

If they are not aligned, check that the two halves of the box are properly closed together. With a small screwdriver, from the outer side of the assembled box, realign faston females and relay slots.

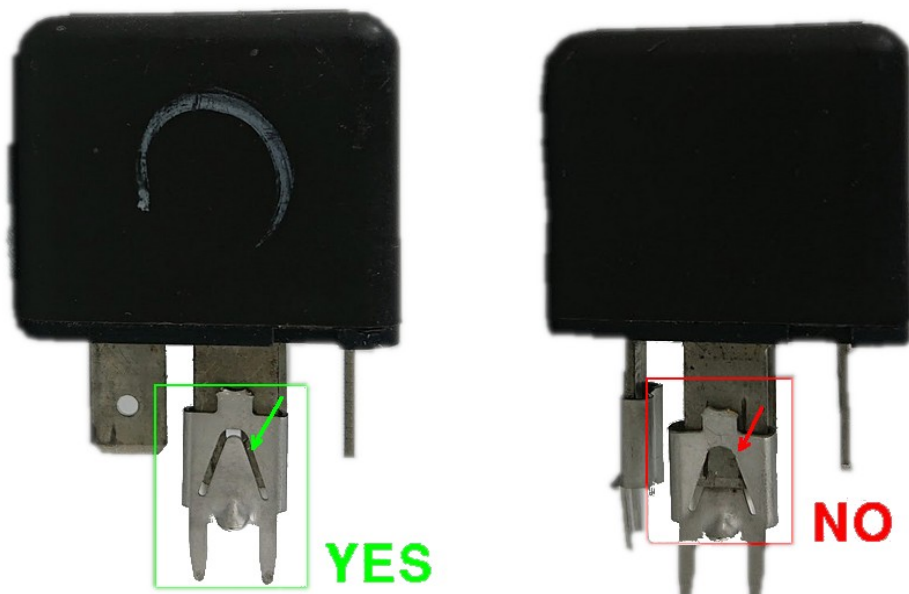
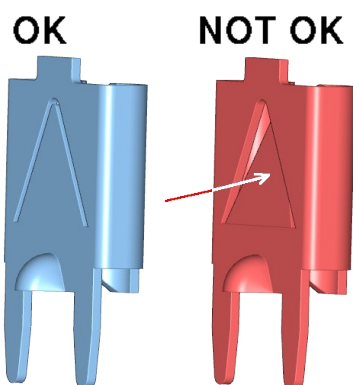
2 - if the relay enters halfway through and then refuses to enter, DO NOT FORCE IT IN.

Remove the relay, and make sure that the little tab of the female is not 'crossed' in a way to refuse insertion of the male pin.

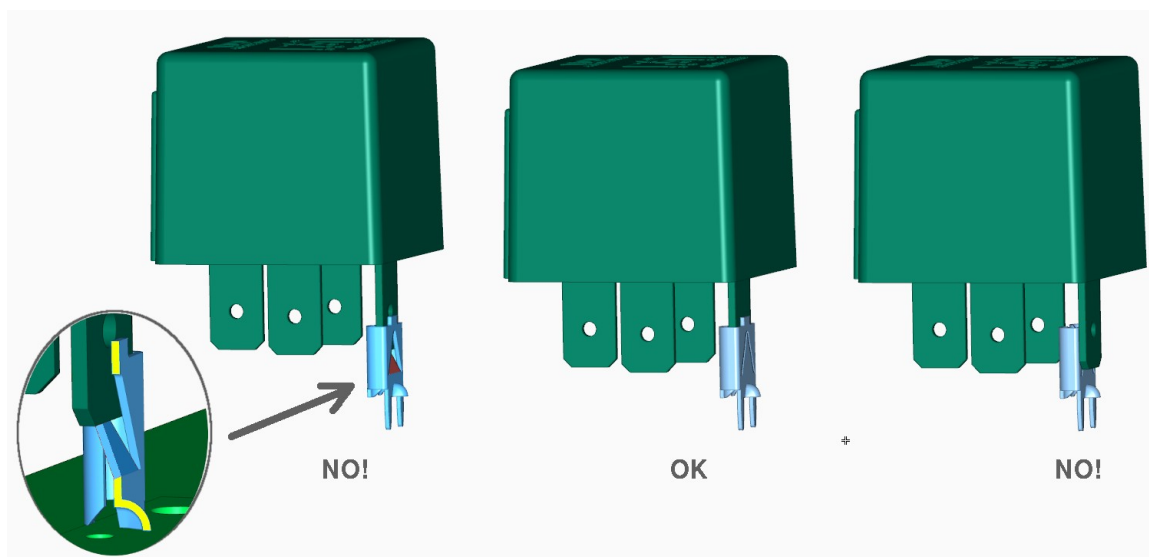
In doubt, remove the relays, verify that the slots in the plastic case are aligned with the females, check that the little tab is not in the way, and reinsert the relay.

You must feel that the relay goes in properly, and that it doesn't stop halfway through. Also, it must seat itself properly on the plastic case of the box.

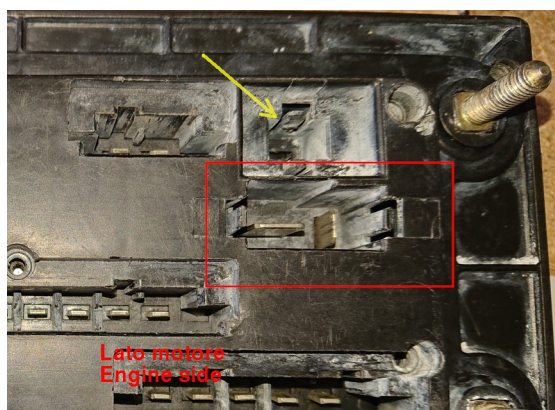
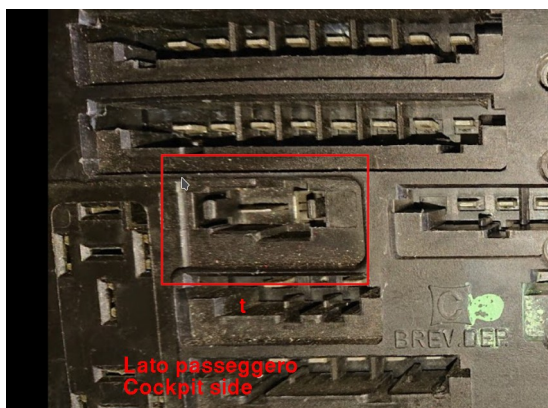
Important note No.1: these two connectors, unlike all the others, are not held in place by retaining hooks: therefore the thickness of three of the four male blades has been increased in order to guarantee a better lock and electrical connection. For this reason, the first insertion of these connectors after assembly, may be more difficult: press them fully in place making sure that the connectors properly slide fully into the housing.

Less important note No.2: the pin indicated by the arrow (engine side) is not connected to anything.

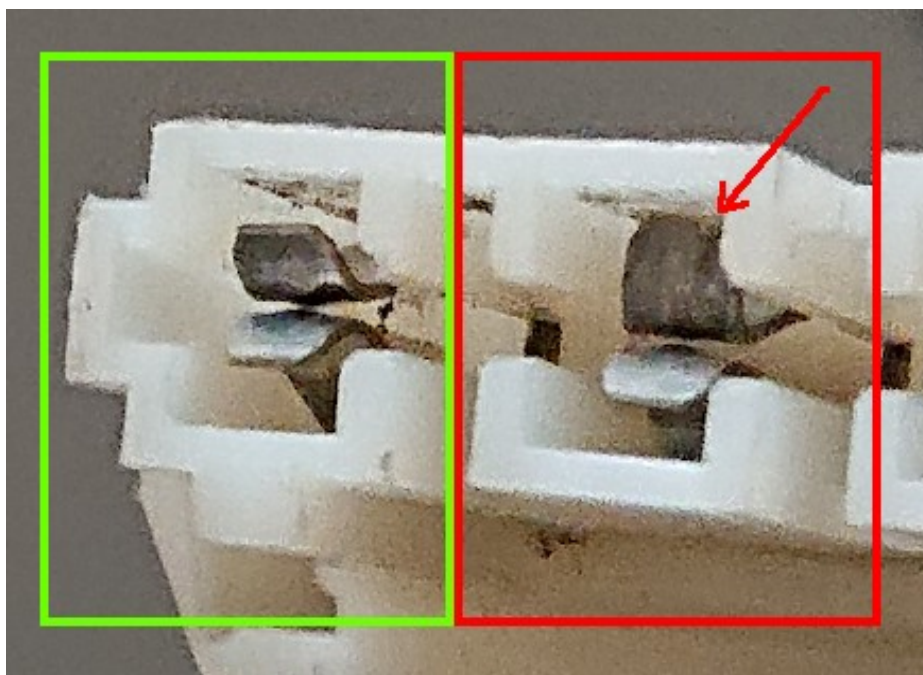
Do NOT apply excessive force on the connector: if you encounter excessive resistance and the connector refuses to 'click' properly, look at all the female metal contact inside the connector and make sure that the edges of the metal females are not bent.

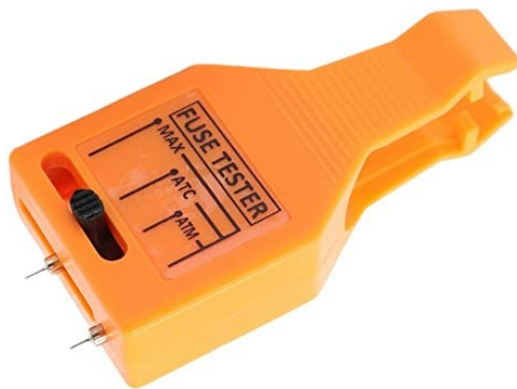
The small holes on the fuse cover are designed to be used to access the fuses with a tester, or with a fuse/extractor tool such as the one in the picture.

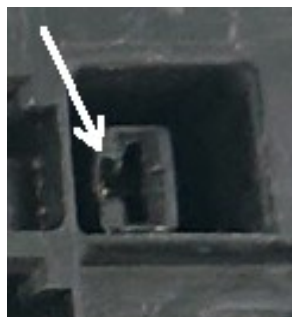
Now open the two halves of the box gently, **keeping in mind that the ground cable is locked in place by a retaining pin**. With an extractor, or a small screwdriver, press the locking pin so that the ground female connector is released from the box. Do not force it out, **do not pull hard on the ground cable!**
